Lakeview Beach—Sanitary Survey Report

Fall 2011

GREAT LAKES BEACH ANNUAL SANITARY SURVEY

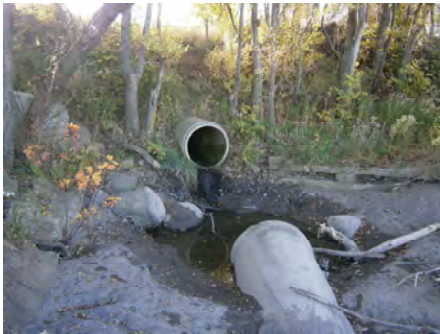
Lakeview—West

As a result of the sanitary survey, three outfalls were identified as potential sources of water pollution. An “outfall” is defined as the point where a storm water conveyance system discharges into a natural body of water such as a lake, river, stream, or wetland. The photos below show the outfalls. As part of this project, water samples were taken during both dry weather and after rain events. They were then analyzed for bacterial contamination. This analysis was used as an indication of whether these outfalls were contributing to the higher bacteria counts occasionally observed in the Lake. Sampling was conducted weekly, beginning August 17th and concluding on October 12th. The table below provides the *E.coli* concentrations found as a result of sample analysis.

To interpret the results, the *E. coli* concentration listed in the previous table is compared to a water quality standard of 576 CFU/100 mL. The threshold of 576 was created by the USEPA for storm water analysis. Results exceeding 576 are an indication of a high bacteria load and will most likely affect the water quality at the beach. In general, beach water quality is affected by two factors; local wildlife and rainfall. The Cuyahoga County Board of Health is working with the United States Geological Survey (USGS) to determine how much of an impact wildlife has on Lakeview. The results of this project show that the outfalls located near the beach are heavily influenced by rain. This is common among beaches in a region where older infrastructure is still present. There are a number of options available to help effectively reduce the amount of pathogenic bacteria such as *E. coli* flowing into Lake Erie from these outfalls, including:
