Parklawn Beach—Sanitary Survey Report

Fall 2011

Cuyahoga County Board of Health • 5550 Venture Drive • Parma, Ohio 44130 • (216) 201-2000 • www.ccbh.net • estaff@ccbh.net

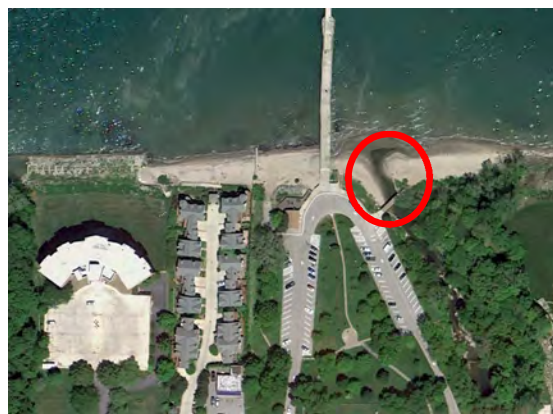
GPS: 41.48288 (N), -81.86785 (W)

As a result of the sanitary survey, one outfall was identified as potential sources of water pollution. An “outfall” is defined as the point where a storm water conveyance system discharges into a natural body of water such as a lake, river, stream, or wetland. The photo to the right shows the outfall along with the GPS coordinates. As part of this project, water samples were taken during both dry weather and after rain events. They were then analyzed for bacterial contamination. This analysis was used as an indication of whether these outfalls were contributing to the higher bacteria counts occasionally observed in the Lake. Sampling was conducted weekly, beginning August 17th and concluding on October 12th. The table below provides the *E.coli* concentrations found as a result of sample analysis.

BEACH NAME	OUTFALL LOCATION	COLLECTION DATE	E COLI CFU/100mL	RECENT RAINFALL	RAINFALL AMOUNT (INCHES)
Parklawn/Wagar	Spencer Creek	8/17/2011	310	<72 hours	0.35
Parklawn/Wagar	Spencer Creek	8/24/2011	5400	<24 hours	0.46
Parklawn/Wagar	Spencer Creek	8/31/2011	275	>72 hours	0.22
Parklawn/Wagar	Spencer Creek	9/6/2011	750	<72 hours	1.75
Parklawn/Wagar	Spencer Creek	9/13/2011	891	<72 hours	0.28
Parklawn/Wagar	Spencer Creek	9/20/2011	2550	<48 hours	1.06
Parklawn/Wagar	Spencer Creek	9/26/2011	720	<24 hours	1.48
Parklawn/Wagar	Spencer Creek	10/3/2011	2300	<24 hours	0.36
Parklawn/Wagar	Spencer Creek	10/12/2011	1400	<24 hours	0.38

To interpret the results, the *E.coli* concentration listed in the table above is compared to a water quality standard of 576 CFU/100 mL. The threshold of 576 was created by the USEPA for storm water analysis. Results exceeding 576 are an indication of a high bacteria load and will most likely affect the water quality at the beach. The results show that the outfalls located near the beach are primarily influenced by rain. This is common among beaches in Cuyahoga County and other areas where older infrastructure is still present. There are a number of options available to help effectively reduce the amount of pathogenic bacteria such as *E. coli* flowing into Lake Erie from these outfalls, including:
