Royal Acres Beach—Sanitary Survey Report

Fall 2011

Cuyahoga County Board of Health • 5550 Venture Drive • Parma, Ohio 44130 • (216) 201-2000 • www.ccbh.net • estaff@ccbh.net

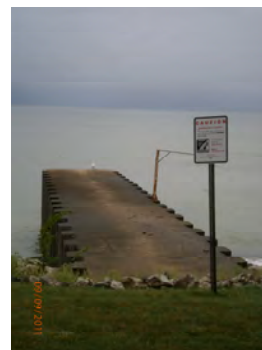
As a result of the sanitary survey, two outfalls were identified as potential sources of water pollution. An "outfall" is defined as the point where a storm water conveyance system discharges into a natural body of water such as a lake, river, stream, or wetland. The photo to the right shows the outfalls. As part of this project, water samples were taken during both dry weather and after rain events. They were then analyzed for bacterial contamination. This analysis was used as an indication of whether these outfalls were contributing to the higher bacteria counts occasionally observed in the Lake. Sampling was conducted weekly, beginning August 17th and concluding on October 12th. The table below provides the *E.coli* concentrations found as a result of sample analysis.

East 252nd Street

Lloyd Road
