# Century Beach—Sanitary Survey Report

Fall 2011

## GREAT LAKES BEACH ANNUAL SANITARY SURVEY

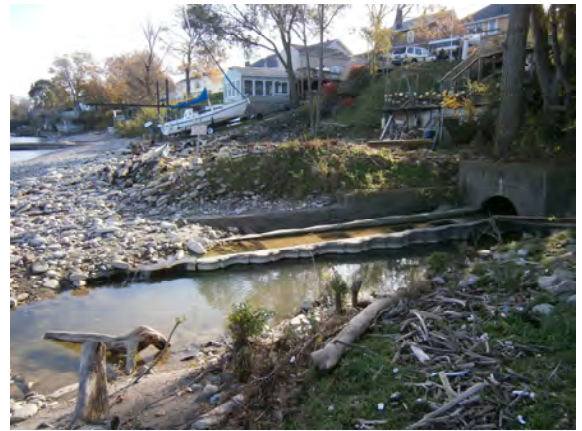
GPS: 41.47777, -082.15336

As a result of the sanitary survey, one outfall was identified as a potential source of water pollution. An “outfall” is defined as the point where a storm water conveyance system discharges into a natural body of water such as a lake, river, stream, or wetland. The photo to the right shows the outfall along with the GPS coordinates. As part of this project, water samples were taken during both dry weather and after rain events. They were then analyzed for bacterial contamination. This analysis was used as an indication of whether this outfall was contributing to the higher bacteria counts occasionally observed in the Lake. Sampling was conducted weekly, beginning August 17<sup>th</sup> and concluding on October 12<sup>th</sup>. The table below provides the *E.coli* concentrations found as a result of sample analysis.

BEACH NAME	OUTFALL LOCATION	GPS (N)	GPS (W)	COLLECTION DATE	E COLI CFU/100mL	RECENT RAINFALL	RAINFALL AMOUNT (INCHES)
Century	East of Beach	41.47777	-082.15336	8/17/2011	833	<72 hours	0.35
Century	East of Beach	41.47777	-082.15336	8/24/2011	3886	<24 hours	0.46
Century	East of Beach	41.47777	-082.15336	8/31/2011	967	>72 hours	0.22
Century	East of Beach	41.47777	-082.15336	9/6/2011	370	<72 hours	1.75
Century	East of Beach	41.47777	-082.15336	9/13/2011	2600	<72 hours	0.28
Century	East of Beach	41.47777	-082.15336	9/20/2011	5400	<48 hours	1.06
Century	East of Beach	41.47777	-082.15336	9/26/2011	630	<24 hours	1.48
Century	East of Beach	41.47777	-082.15336	10/3/2011	2560	<24 hours	0.36
Century	East of Beach	41.47777	-082.15336	10/12/2011	89600	<24 hours	0.38

To interpret the results, the *E.coli* concentration listed in the table above is compared to a water quality standard of 576 CFU/100 mL. The threshold of 576 was created by the USEPA for storm water analysis. Results exceeding 576 are an indication of a high bacteria load and will most likely affect the water quality at the beach. The results show that the outfall located on the beach is primarily influenced by rain. This is common among beaches in this region and other areas where older infrastructure is still present. There are a number of options available to help effectively reduce the amount of pathogenic bacteria such as *E. coli* flowing into Lake Erie from these outfalls, including:

SOURCE TRACKING NEEDS TO BE CONDUCTED TO DETERMINE POINT-SOURCE POLLUTION IMPACTING THE BEACH AREA & OUTFALL FLOWING INTO BEACH.

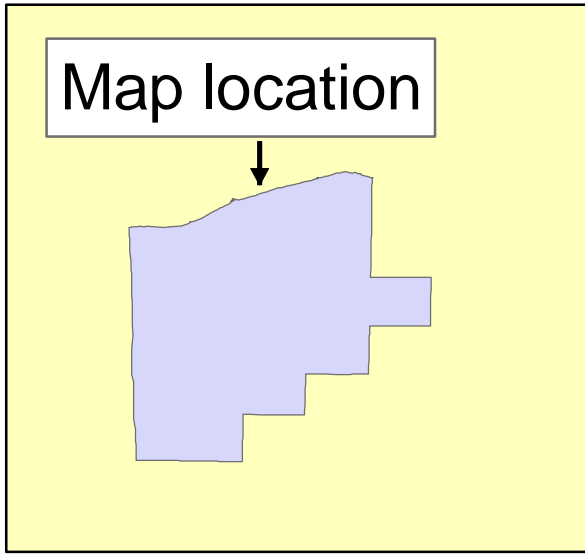
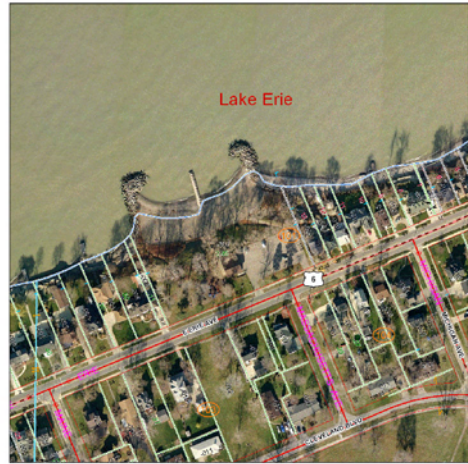
**Century Beach Area**

Lorain County Internet Maps  
Mark R. Stewart, Auditor  
Map image generated at: 10/17/2011 9:48:42 PM

CSO SSO Locations
-

Sampling Locations 2011
-
