Columbia Park Beach—Sanitary Survey Report

Fall 2011

GREAT LAKES BEACH ANNUAL SANITARY SURVEY

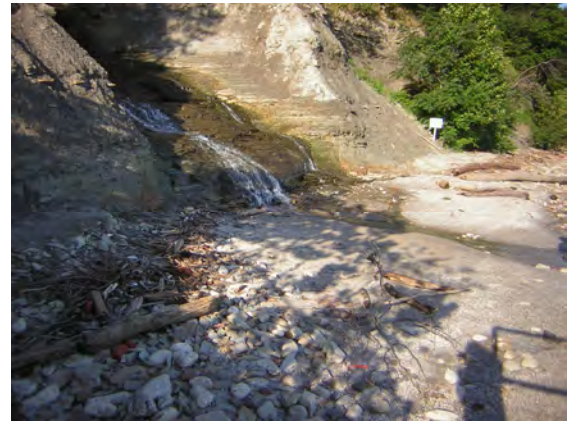
GPS: 41.48576 -81.90177

As a result of the sanitary survey, one outfall was identified as a potential source of water pollution. An “outfall” is defined as the point where a storm water conveyance system discharges into a natural body of water such as a lake, river, stream, or wetland. The photo to the right shows the outfall along with the GPS coordinates. As part of this project, water samples were taken during both dry weather and after rain events. They were then analyzed for bacterial contamination. This analysis was used as an indication of whether this outfall was contributing to the higher bacteria counts occasionally observed in the Lake. Sampling was conducted weekly, beginning August 17th and concluding on October 12th. The table below provides the *E.coli* concentrations found as a result of sample analysis.

BEACH NAME	OUTFALL LOCATION	COLLECTION DATE	E COLI CFU/100mL	RECENT RAINFALL	RAINFALL AMOUNT (INCHES)
Columbia Park	Wischmeyer Creek	8/17/2011	967	<72 hours	0.35
Columbia Park	Wischmeyer Creek	8/24/2011	6600	<24 hours	0.46
Columbia Park	Wischmeyer Creek	8/31/2011	1767	>72 hours	0.22
Columbia Park	Wischmeyer Creek	9/6/2011	780	<72 hours	1.75
Columbia Park	Wischmeyer Creek	9/13/2011	1100	<72 hours	0.28
Columbia Park	Wischmeyer Creek	9/20/2011	4000	<48 hours	1.06
Columbia Park	Wischmeyer Creek	9/26/2011	4600	<24 hours	1.48
Columbia Park	Wischmeyer Creek	10/3/2011	3250	<24 hours	0.36
Columbia Park	Wischmeyer Creek	10/12/2011	63400	<24 hours	0.38

To interpret the results, the *E.coli* concentration listed in the table above is compared to a water quality standard of 576 CFU/100 mL. The threshold of 576 was created by the USEPA for storm water analysis. Results exceeding 576 are an indication of a high bacteria load and will most likely affect the water quality at the beach. The results show that the outfall located on the beach is primarily influenced by rain. This is common among beaches in Cuyahoga County and other areas where older infrastructure is still present. There are a number of options available to help effectively reduce the amount of pathogenic bacteria such as *E. coli* flowing into Lake Erie from these outfalls, including:
