Edgecliff Beach—Sanitary Survey Report

Fall 2011

GREAT LAKES BEACH ANNUAL SANITARY SURVEY

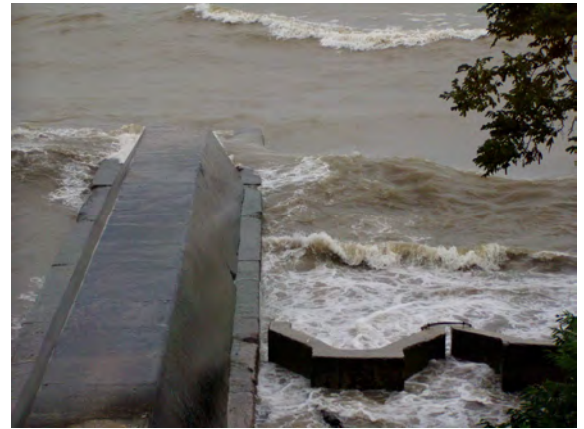
GPS: 41.61010, -81.53649

As a result of the sanitary survey, one outfall was identified as a potential source of water pollution. An “outfall” is defined as the point where a storm water conveyance system discharges into a natural body of water such as a lake, river, stream, or wetland. The photo to the right shows the outfall along with the GPS coordinates. As part of this project, water samples were taken during both dry weather and after rain events. They were then analyzed for bacterial contamination. This analysis was used as an indication of whether this outfall was contributing to the higher bacteria counts occasionally observed in the Lake. Sampling was conducted weekly, beginning August 17th and concluding on October 12th. The table below provides the *E.coli* concentrations found as a result of sample analysis.

BEACH NAME	OUTFALL LOCATION	COLLECTION DATE	E COLI CFU/100mL	RECENT RAINFALL	RAINFALL AMOUNT (INCHES)
Edgecliff	Outfall at Beach	8/17/2011	74000	<72 hours	0.35
Edgecliff	Outfall at Beach	8/24/2011	8400	<24 hours	0.46
Edgecliff	Outfall at Beach	8/31/2011	483	>72 hours	0.22
Edgecliff	Outfall at Beach	9/13/2011	45600	<72 hours	0.28
Edgecliff	Outfall at Beach	9/20/2011	9800	<48 hours	1.06
Edgecliff	Outfall at Beach	9/26/2011	9000	<24 hours	1.48
Edgecliff	Outfall at Beach	10/12/2011	41200	<24 hours	0.38

To interpret the results, the *E.coli* concentration listed in the table above is compared to a water quality standard of 576 CFU/100 mL. The threshold of 576 was created by the USEPA for storm water analysis. Results exceeding 576 are an indication of a high bacteria load and will most likely affect the water quality at the beach. The results show that the outfall located on the beach is primarily influenced by rain. This is common among beaches in Cuyahoga County and other areas where older infrastructure is still present. There are a number of options available to help effectively reduce the amount of pathogenic bacteria such as *E. coli* flowing into Lake Erie from these outfalls, including:
