# Moss Point Beach—Sanitary Survey Report

Fall 2011

## GREAT LAKES BEACH ANNUAL SANITARY SURVEY

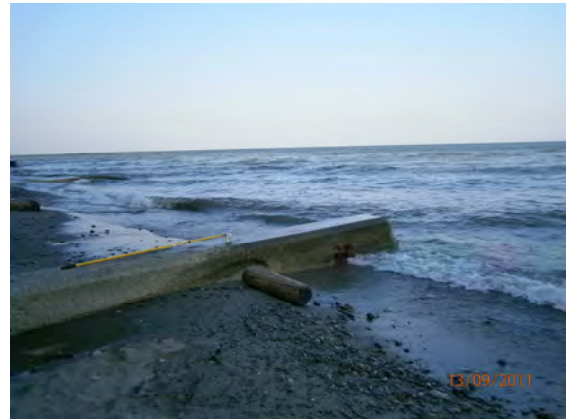
GPS: 41.61250, -81.53239

As a result of the sanitary survey, one outfall was identified as a potential source of water pollution. An “outfall” is defined as the point where a storm water conveyance system discharges into a natural body of water such as a lake, river, stream, or wetland. The photo to the right shows the outfall along with the GPS coordinates. As part of this project, water samples were taken during both dry weather and after rain events. They were then analyzed for bacterial contamination. This analysis was used as an indication of whether this outfall was contributing to the higher bacteria counts occasionally observed in the Lake. Sampling was conducted weekly, beginning August 17<sup>th</sup> and concluding on October 12<sup>th</sup>. The table below provides the *E.coli* concentrations found as a result of sample analysis.
