# **Utopia Beach—Sanitary Survey Report**

Fall 2011

Cuyahoga County Board of Health • 5550 Venture Drive • Parma, Ohio 44130 • (216) 201-2000 • www.ccbh.net • estaff@ccbh.net

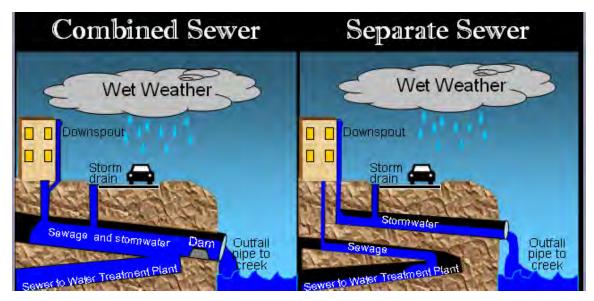
*Modifying the existing sewer system* and separating sanitary waste lines from storm water lines. On average, this is the most expensive and time-consuming solution. However, completely separate conveyance systems ensure that only

storm water runoff enters the outfalls and eventually Lake Erie. Keep in mind that water runoff storm still contain can bacteria from other sources; local wildlife (geese), pet waste, agricultural waste, and discharge from impervious surfaces like streets and parking lots.

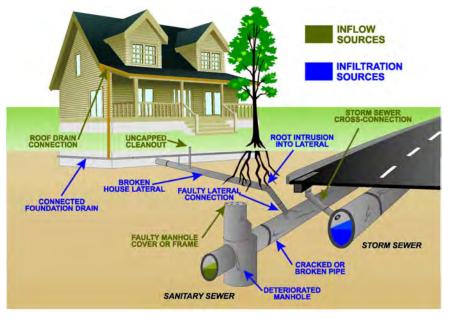
Prevent rain water from infiltrating sanitary sewers. Just like any other structural component of a house, storm water drain lines periodically need to be repaired or replaced. Rain water from gutters, downspouts, footer drains and lateral lines can infiltrate the sanitary sewer system if cracks or leaks are present. Too much rainwater in sanitary sewers often results in overflows at the sewage treatment plants which spill into area waterways and eventually Lake Erie. Homeowners interested in an evaluation of their drainage system can contact local storm water consulting/engineering firms or their municipal sewer department.
