Shoreby Beach—Sanitary Survey Report

Fall 2011

Cuyahoga County Board of Health • 5550 Venture Drive • Parma, Ohio 44130 • (216) 201-2000 • www.ccbh.net • estaff@ccbh.net

GREAT LAKES BEACH ANNUAL SANITARY SURVEY

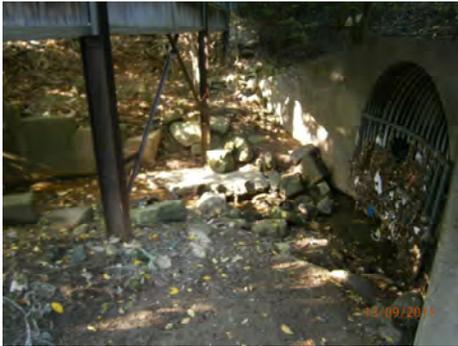
| BEACH NAME | OUTFALL LOCATION | GPS (N) | GPS (W) | COLLECTION DATE | E COLI CFU/100mL | RECENT RAINFALL | RAINFALL AMOUNT (INCHES) |
|---|---|---|---|---|---|---|---|
| Shoreby | Shaw Brook | 41.55295 | -81.60043 | 8/17/2011 | 600 | <72 hours | 0.35 |
| Shoreby | Shaw Brook | 41.55295 | -81.60043 | 8/24/2011 | 20000 | <24 hours | 0.46 |

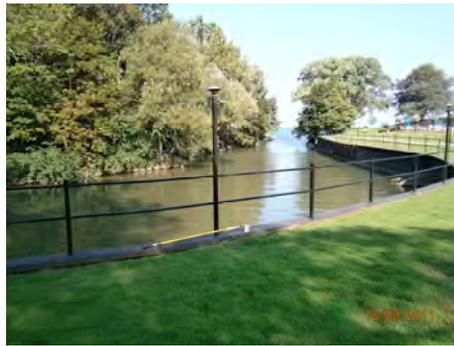
| BEACH NAME | OUTFALL LOCATION | GPS (N) | GPS (W) | COLLECTION DATE | E COLI CFU/100mL | RECENT RAINFALL | RAINFALL AMOUNT (INCHES) |
|---|---|---|---|---|---|---|---|
| Shoreby | Dugway Brook | 41.55403 | -81.60943 | 8/24/2011 | 19600 | <24 hours | 0.46 |
| Shoreby | Dugway Brook | 41.55403 | -81.60943 | 10/3/2011 | 19500 | <24 hours | 0.36 |

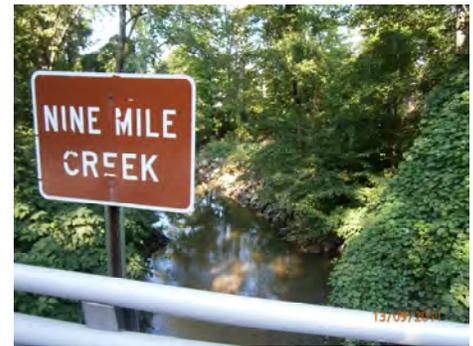
| BEACH NAME | OUTFALL LOCATION | GPS (N) | GPS (W) | COLLECTION DATE | E COLI CFU/100mL | RECENT RAINFALL | RAINFALL AMOUNT (INCHES) |
|---|---|---|---|---|---|---|---|
| Shoreby | Nine Mile Creek | 41.55780 | -81.60032 | 8/24/2011 | 29400 | <24 hours | 0.46 |
| Shoreby | Nine Mile Creek | 41.55780 | -81.60032 | 10/3/2011 | 27000 | <24 hours | 0.36 |
